Manhole Inspection Summary

Manhole # S21AA1021MH

Location Address: **CLIPPER PARK RD**

Cross Street: **BALMAR MEWS**

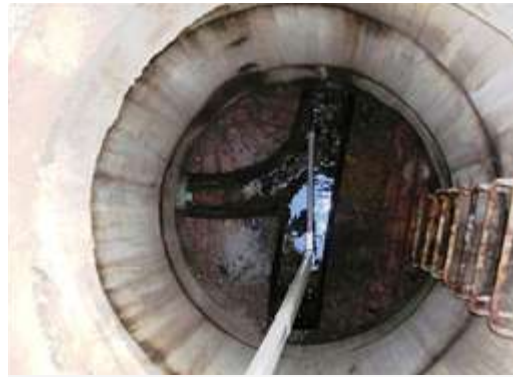
Top View

Evidence of surcharge - Bench debris.
Channel debris.

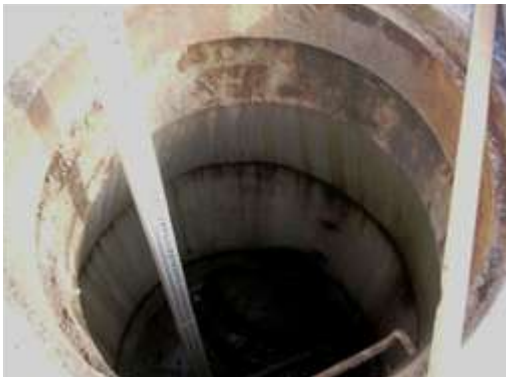
Defect

Frame leaks. Adjustment deterioration
and infiltration. Corbel and Barrel
infiltration - other side.

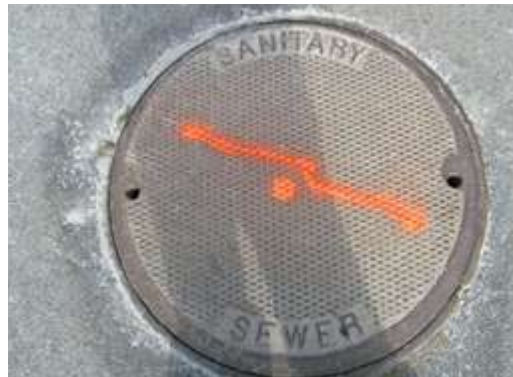
Defect

Cracked lid.

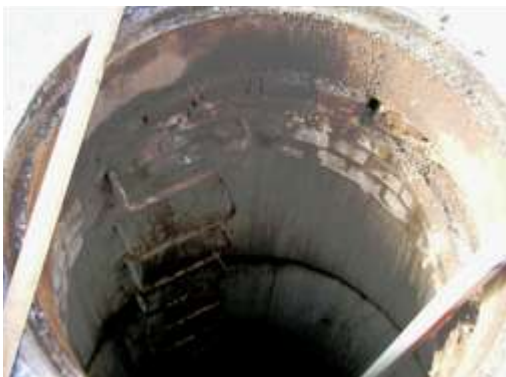
Defect

Frame leaks. Adjustment deterioration,
loose brick and infiltration. Corbel
infiltration - other side.

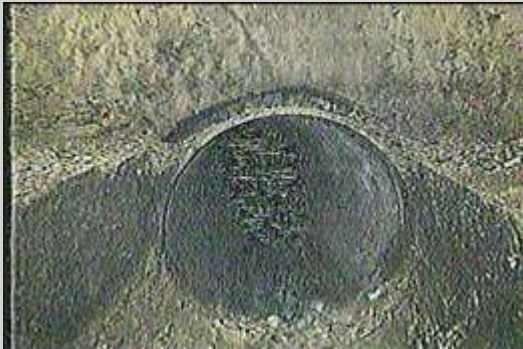
10 in. Circular Gravity Sewer Pipe Out @ 12 O'Clock

Infiltration: **Evidence** Pipe Seal Cond: **Unknown**

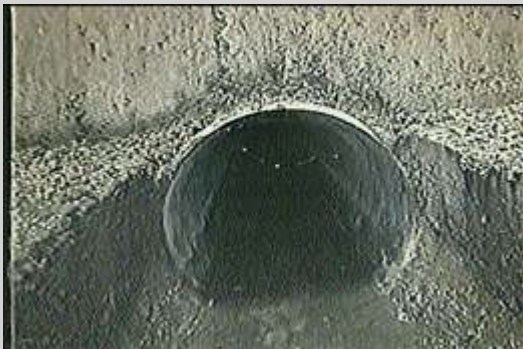
10 in. Circular Gravity Sewer Pipe In @ 6 O'Clock

Infiltration: **Evidence** Pipe Seal Cond: **Unknown**

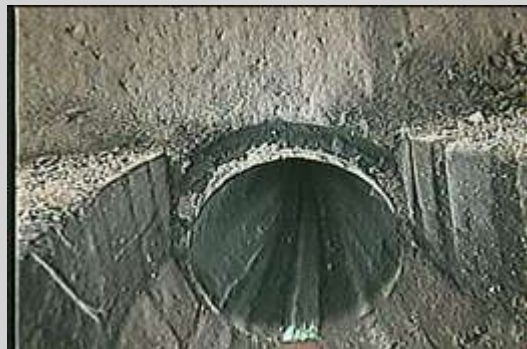
8 in. Circular Gravity Sewer

Infiltration: **Evidence**
